**Flood Control Project Maintenance
Levee Inspections**
LMA District Cover Sheet
Spring 2020 Levee Inspection Results

Sutter Maintenance Yard East Levee Sacramento River

Spring 2020 Levee Inspection Results

| Waterway | | | Bank | Unit Miles |
|--|---|---|---|---|
| Unit No. 01 Sacramento River | | | Left | 19.85 |

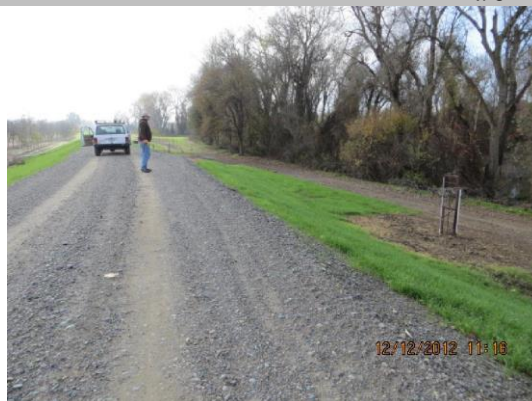
Photo 1 of 3 : UCIP_SP_2020_55552_47210.jpg

DS_ID:17327
FS_ID:55552
EP_NO: 9528
Repair Type: Non-Urgent
Crossing Status: Found
UCIP Comments: 07/31/2019 Record has been updated to Non-Urgent; internal inspection found some issues with the pipe. Pipe has been noted as abandoned since 2012. Recommend LMA prepare a contingency plan for increased inspections during high-water to identify any pipe integrity or levee integrity issues that might arise with abandoned pipe. Record will remain in UCIP's list as part of future inspections until the pipe is properly removed or abandoned according to Title 23 requirements. Need to clarify ownership for this crossing. (O. Magana - DWR UCIP)04/19/2017 Abandoned- needs to be done so properly. (DWR Sutter Yard- Afreitag)10/31/2016 Abandoned. (DWR Sutter Yard- Afreitag)06/13/2016 Pipe was internally cleaned and camera inspected by Nor-Cal Pipeline Services on 10-29-2015. Pipe length through levee is 75.1ft long. The inspection showed some signs of rust but no holes or other deterioration were found. Pics of exposed pipe ends were uploaded on 04/01/2015 After the inspection the pipe ends were capped and reburied.04/14/2016 Same as last inspection.04/01/2015 Both ends of pipe have been dug up in preparation for internal camera inspections. Pipe shows some rust but appears to be in decent shape. 06/30/2014 Same as last inspection.12/18/2013 Same as last inspection.07/23/2013 Same as last inspection.12/12/2012 Only buried slide gate structure found. (P. Amatya - DWR UCIP)

WS view: overview

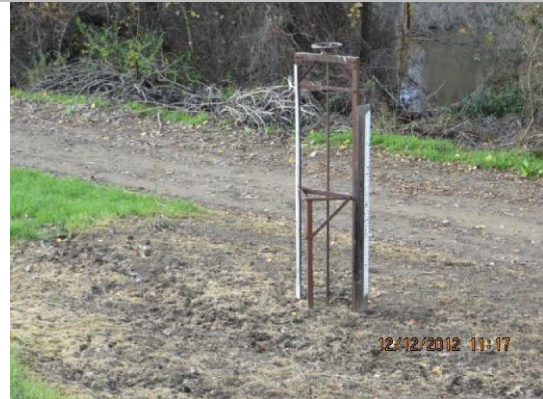
Photo 2 of 3 : UCIP_SP_2020_55552_47209.jpg

WS view: buried slide gate

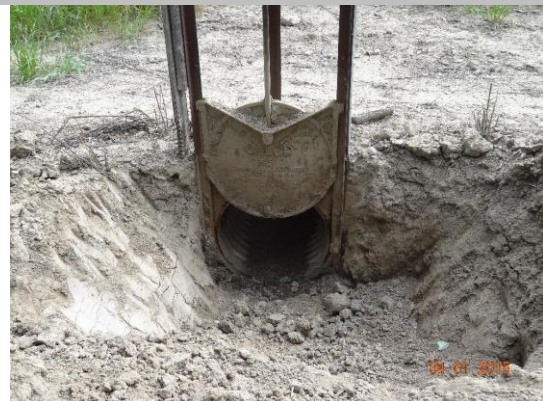
Photo 3 of 3 : UCIP_SP_2020_55552_73649.jpg

WS pipe end

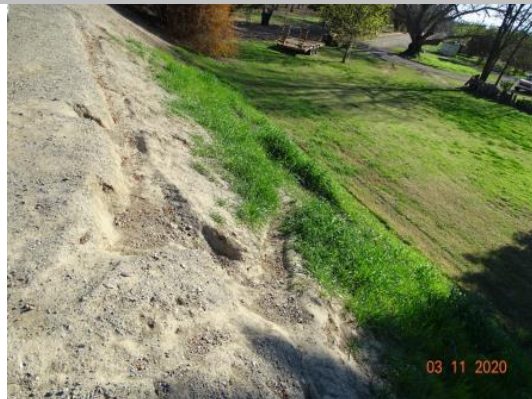
Photo 1 of 1 : SP_2020_ST0003_264_139_20200313_00281.jpg

View of the levee slope damaged by vehicular traffic. Spring 2020.

| S3 : Repair the levee slope damaged by vehicle traffic and prevent access where possible. | | | | | |

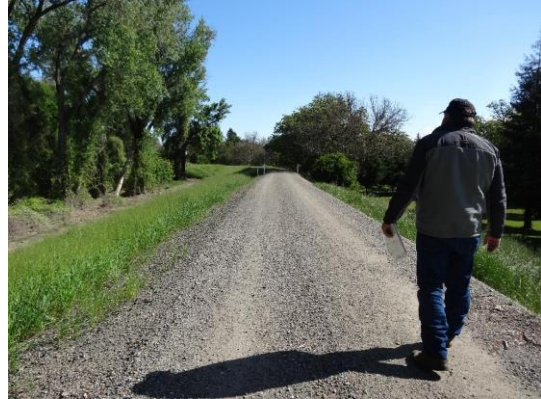
Photo 1 of 3 : UCIP_SP_2020_56038_75043.jpg

| DS_ID:17351 FS_ID:56038 EP_NO: N/A Repair Type: Non-Urgent Crossing Status: Not Found UCIP Comments: 07/31/2019 Coordinates were recorded incorrectly according to LMA supervisor, coordinates have been updated from 39.250830, -121.998184 to 39.2506573, -121.9983807. Record has been updated from No Action Needed to Non-Urgent due to missing records indicating status of pipe through the levee. The DWR DMP Geophysical Investigation includes d/s levee section where point was re-located. No signal was present to show evidence of pipe under geophysical study however, pipe cannot be removed from list. Record will remain in UCIP's list until future levee improvement projects can confirm status of pipe through this section of the levee. (O. Magana - DWR UCIP)04/19/2017 Unable to locate. (DWR Sutter Yard-Afreitag)10/31/2016 Unable to locate. (DWR Sutter Yard-Afreitag)06/01/2016 Unable to locate.04/14/2016 Same as last inspection. Note photos have been updated.04/01/2015 THIS PIPE IS NOT FOUND. The pictures for this pipe belong to the pipe at LM 8.700. 06/30/2014 Same as last inspection.12/18/2013 Same as last inspection.07/23/2013 Same as last inspection.12/12/2012 Only partially buried CMP riser found. (P. Amatya - DWR UCIP) FIELD_STRUCT_DESC: *ABANDONED* 24-inch corrugated metal drainage pipe through the levee, 16.5 feet below the crown. Slide gate on the waterside (WS), removed. Pipe is plugged and abandoned in place. [Additional Reference(s): DWR Levee Log, 2002, noted as plugged and abandoned in place with slide gate removed. USACE Sacramento O&M Manual 136, March 1960 (HLM 8.67)]. FS Date: 7/31/2019 1:46:00 PM | | | | | |

Probable location of crossing with view upstream.

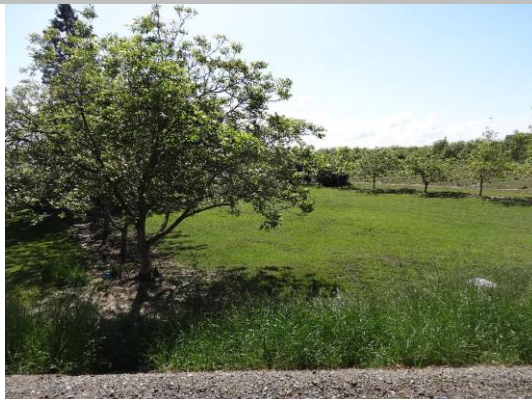
Photo 2 of 3 : UCIP_SP_2020_56038_75044.jpg

Probable location of crossing along property line at line of trees along landside (LS).

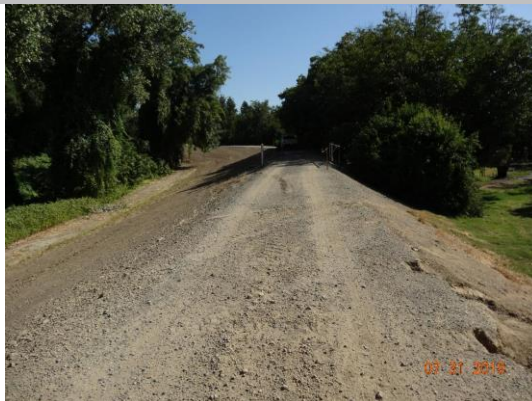
Photo 3 of 3 : UCIP_SP_2020_56038_81904.jpg

Overview of levee crown looking u/s towards where pipe crossing should be.

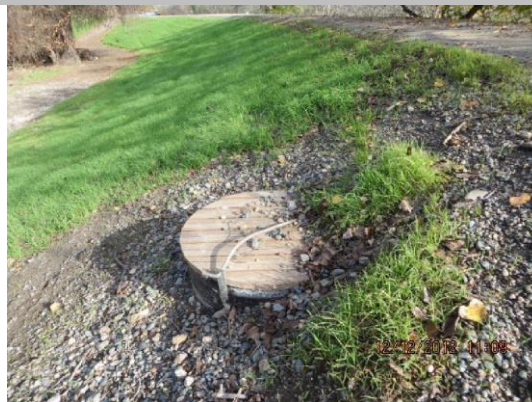
Photo 2 of 3 : UCIP_SP_2020_56039_74661.jpg

42-inch riser on WS shoulder.

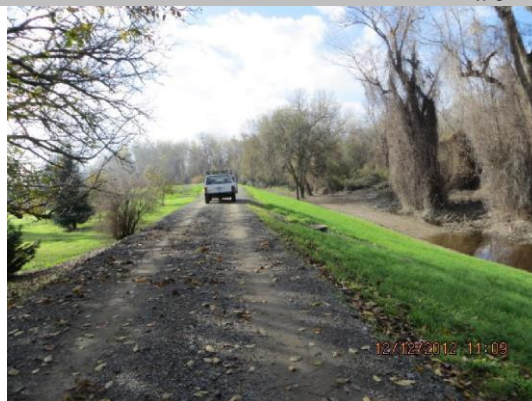
Photo 3 of 3 : UCIP_SP_2020_56039_74660.jpg

View from crown of levee looking downstream.

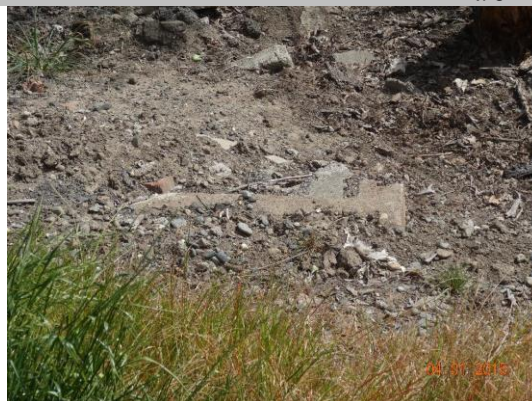
Photo 1 of 3 : UCIP_SP_2020_56040_74665.jpg

| DS_ID:17353 FS_ID:56040 EP_NO: 4491 Repair Type: Non-Urgent Crossing Status: Found UCIP Comments: 07/31/2019 Record has been downgraded from Urgent to Non-Urgent, modifications have been made to pipe. No permit has been identified authorizing the 4-inch sleeved pipe through the 24-inch pipe. Recommend auditing record to determine current owner. Recommend monitoring WS toe where pipe shows signs of deterioration. (O. Magana - DWR UCIP)08/30/2018 Same as last inspection; could not find LS pipe end so recommend internal pipe inspection. Crossing to remain Urgent (D. Sanoski - DWR UCIP).04/19/2017 4in. pipe still showing signs of deterioration near WS toe. (DWR Sutter Yard- Afreitag)10/31/2016 Pipe still exposed along the WS toe and is rusted and corroded. If it is still in use by the owner then it should be rebuilt.(DWR Sutter Yard- Afreitag)06/13/2016 Pipe was dug up on WS and photographed. It was originally selected for internal inspection but was unable to be as there was no access to the inside of the 4" pipe. (DWR Sutter Yard - afreitag)04/14/2016 Signs of corrosion on pipe and valve on LS. Pipe in use according to Bryan Reniff of Sutter Yard. (DWR UCIP - kfazel)08/28/2015 Pipe was dug up and located on the WS levee toe. (DWR Sutter Yard - afreitag)06/30/2014 Same as last inspection. (DWR Sutter Yard - afreitag)12/18/2013 Same as last inspection. (DWR Sutter Yard - afreitag)07/23/2013 Same as last inspection. (DWR Sutter Yard - afreitag)12/11/2012 Only abandoned slide gate found on WS. (DWR UCIP - pamatyra) FIELD_STRUCT_DESC: 4-inch steel drainage pipe sleeved through 24-inch corrugated metal pipe through the levee, 16.7 feet below the crown. Annular space has been pressure grouted. Slide gate on the waterside (WS) end. Gate valve at the landside (LS) toe. (Permit No. 4491, 1964 - Blackmore). [Additional Reference(s): DWR Levee Log, 2002. USACE Sacramento O&M Manual 136, March 1960 (HLM 8.74)]. FS Date: 7/31/2019 1:44:00 PM | | | | | | |

concrete headwall found near LS toe

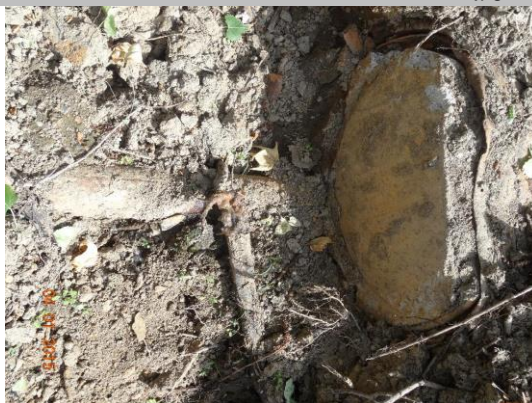
Photo 2 of 3 : UCIP_SP_2020_56040_74664.jpg

View of pipe dug up near WS toe

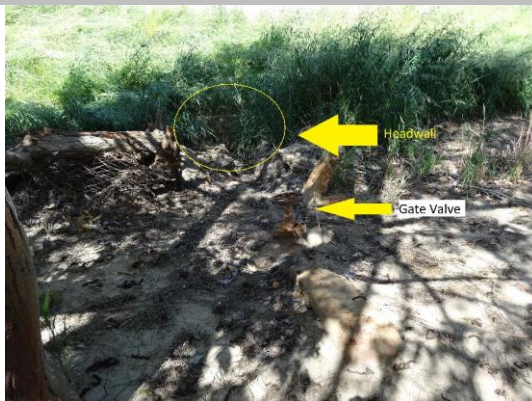
Photo 3 of 3 : UCIP_SP_2020_56040_75051.jpg

LS view of toe: corroded pipe and gate valve; concrete headwall

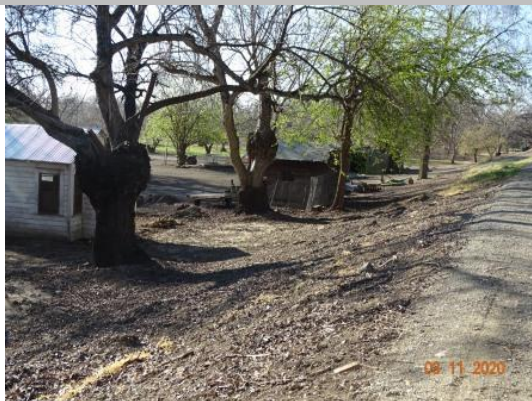
Photo 1 of 1 : SP_2020_ST0003_264_2_20200313_00283.jpg

View of the buildings along the landside toe. Spring 2020.

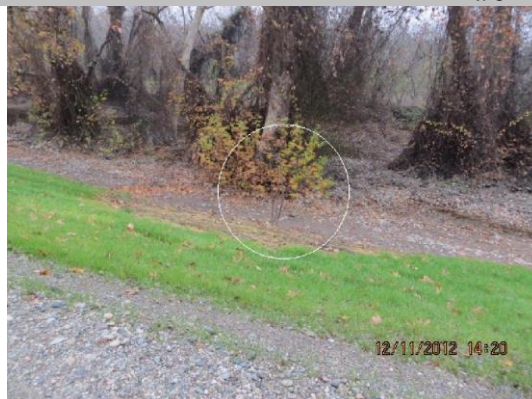
Photo 1 of 3 : UCIP_SP_2020_56041_47216.jpg

DS_ID:17354
FS_ID:56041
EP_NO: 9523
Repair Type: Non-Urgent
Crossing Status: Indicator Found
UCIP Comments: 07/31/2019 Record has been updated from No Action Needed to Non-Urgent, pipe has been abandoned. No other information is available about potential abandoned pipe or method of abandonment. Recommend LMA prepare a contingency plan for increased inspections during high-water to identify any pipe integrity or levee integrity issues that might arise with abandoned pipe. Need to audit record to determine current owner (ABO issued). 12-inch is buried on the WS and unable to inspect condition of slide gate. (O. Magana - DWR UCIP)04/19/2017 Abandoned- needs to be done so properly. (DWR Sutter Yard- Afreitag)10/31/2016 Abandoned. (DWR Sutter Yard- Afreitag)06/13/2016 61.5ft of this pipe starting from the WS slide gate was internally cleaned and camera inspected by Nor-Cal Pipeline Services on 10/30/2015 Only the pipe segment that was in the levee prism was cleaned and inspected. LS pipe end is still not found.04/16/2016 Bryan Reniff informed us that screw gate has been repaired. Flap gate and screw gate appear new.08/28/2015 Pipe files was mixed up with the pipe at LM8.743. Pipe is abandoned with a damaged screw gate on the WS toe of levee.06/30/2014 Unable to locate.12/18/2013 Unable to locate.07/23/2013 Same as last inspection.

WS view: overview of slide gate on steel structure (belongs to crossing at CLM-8.782)

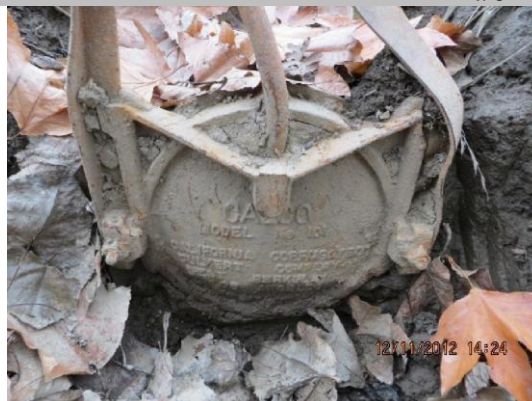
Photo 2 of 3 : UCIP_SP_2020_56041_74668.jpg

view of screwgate on WS toe

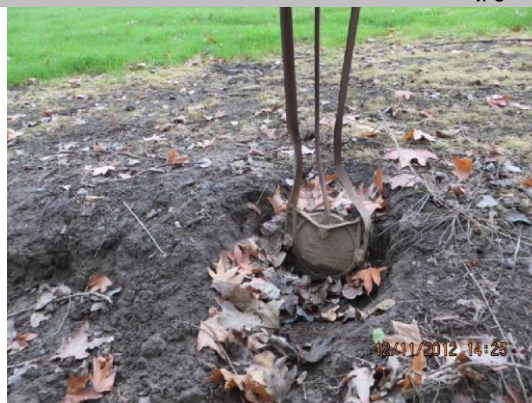
Photo 3 of 3 : UCIP_SP_2020_56041_74667.jpg

FIELD_STRUCT_DESC: 12-inch corrugated metal drainage pipe through the levee, invert 12.5 feet below the crown, not found in 2016. Slide gate on the waterside (WS), found in 2016. (12-inch pipe [HLM 8.78] authorized under Automatic Board Order (ABO) issued as Permit No. 9523, 1974 - Blackmore). [Additional Reference(s): DWR Levee Log, 2002. USACE Sacramento O&M Manual 136, March 1960 (HLM 8.78)].
FS Date: 7/31/2019 1:48:00 PM

view of screwgate on WS toe

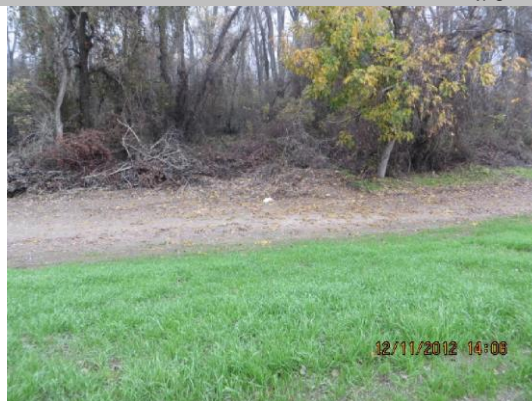
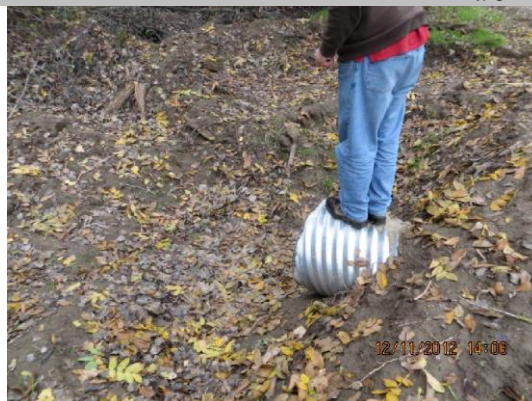
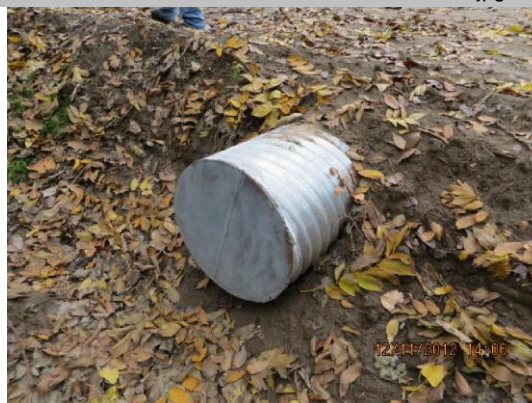
DS_ID:17355
FS_ID:55554
EP_NO: N/A
Repair Type: Non-Urgent
Crossing Status: Found
UCIP Comments: 07/31/2019 Record has been updated to Non-Urgent; internal inspection found some issues with pipe. Pipe has been abandoned since 2012 (both inlet/outlet have been covered to avoid soil buildup inside). Record will remain in UCIP's list as part of future inspections until the pipe is properly removed or abandoned according to Title 23 requirements. Need to clarify ownership for this crossing. (O. Magana - DWR UCIP)04/19/2017 Abandoned- needs to be done so properly. (DWR Sutter Yard- Afreitag)10/31/2016 Abandoned. (DWR Sutter Yard- Afreitag)06/13/2016 Pipe was internally cleaned and camera inspected on 10/30/2015 by Nor-Cal Pipeline Services. WS cap was removed and 100.6ft of pipe were inspected starting from the WS opening. Inspection revealed rusting but no visible holes or other deterioration were found. Pipe was recapped after the inspection. This pipe is always visible so no new photos were taken during the inspection.06/09/2016 Khalida Fazel of UCIP requests that any photos of the pipe when it was exposed for a video inspection be kindly uploaded here.04/01/2015 Pipe is in same condition. It has been selected for an internal camera inspection. New 06/30/2014 Same as last inspection.12/18/2013 Same as last inspection.07/23/2013 Same as last inspection.12/11/2012 CMP pipe on WS capped with steel plate. (P. Amatya - DWR UCIP)

FIELD_STRUCT_DESC: *ABANDONED* 24-inch corrugated metal drainage pipe through the levee, 13.5 feet below the crown. Slide gate on the landside (LS) headwall. Steel plate welded on the waterside (WS) end. [Additional Reference(s): DWR Levee Log, 2002. USACE Sacramento O&M Manual 136, March 1960 (HLM 9.4)].
FS Date: 7/31/2019 1:54:00 PM

WS view: overview

WS view: overview of CMP pipe

WS view: capped CMP pipe

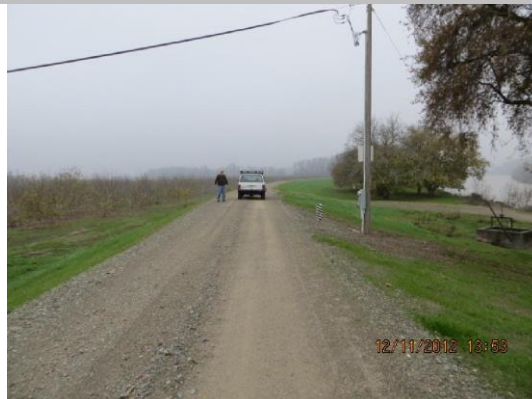
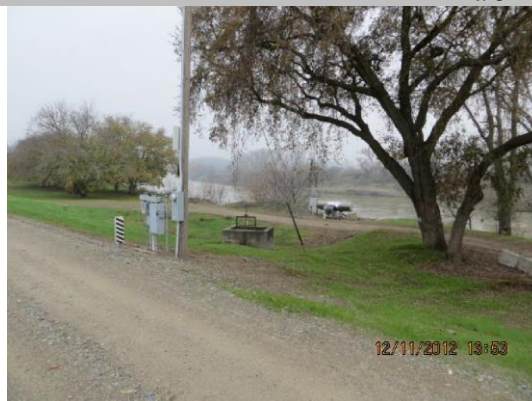
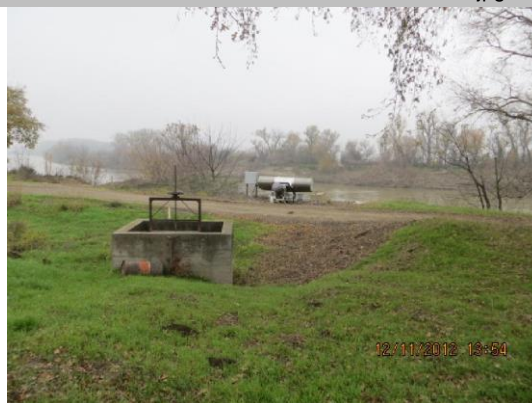
DS_ID:17356
FS_ID:55555
EP_NO: 1082
Repair Type: Non-Urgent
Crossing Status: Found
UCIP Comments: 07/31/2019 Record has been updated from No Action Needed to Non-Urgent due to modifications made to the structure. No permit was found authorizing the modifications to this structure. Pipe was running during inspection and no integrity issues were observed. Permit number 1082 does not clearly define what was installed under permit. Need to coordinate with the CVFPB to obtain updated information regarding the current owner. (O. Magana - DWR UCIP)04/19/2017 Crossing appears to be in good condition. Minor sediment build up in LS outlet. (DWR Sutter Yard- Afreitag)10/31/2016 Crossing appears to be in good condition. (DWR Sutter Yard- Afreitag)06/01/2016 Crossing appears to be in good condition.04/01/2015 Same as last inspection. 06/30/2014 Same as last inspection.12/18/2013 Same as last inspection.07/23/2013 Same as last inspection.12/11/2012 Depression around concrete surge box on WS. It requires detailed investigation or info from owner of this crossing about the depression. Construction of service road might have caused this depression. (P. Amatya - DWR UCIP)

FIELD_STRUCT_DESC: 48-inch corrugated metal irrigation pipe angles (45 degrees) through the levee, 17 feet below the crown. Slide gate in a surge box on the waterside (WS) end. Service poles and meter boxes on the WS slope. Pump on the WS toe. (Permit No. 1082, 1946 - Wilber). [Additional Reference(s): DWR Levee Log, 2002. USACE Sacramento O&M Manual 136, March 1960 (HLM 9.77)].
FS Date: 7/31/2019 10:21:00 AM

Crown view: overview (both sides of the levee)

WS view: overview

WS view: concrete surge box and pump.

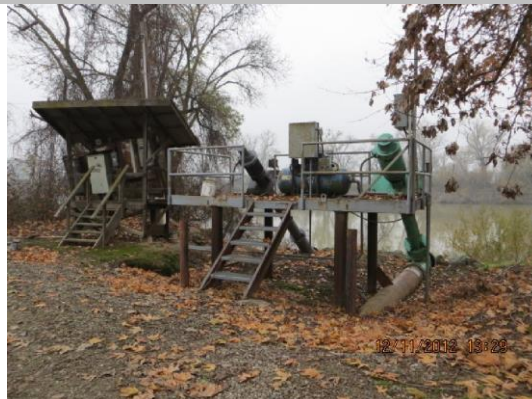
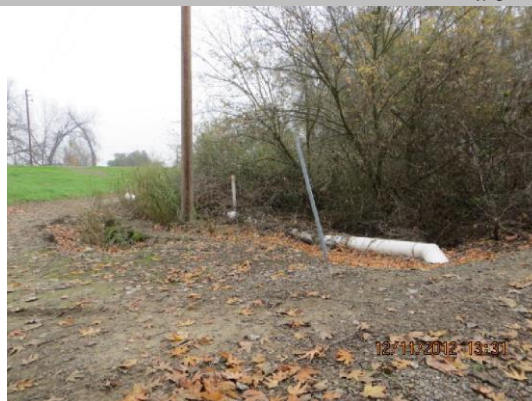
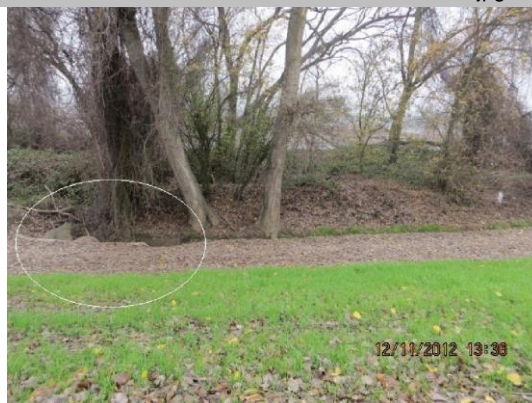
DS_ID:17357
FS_ID:55557
EP_NO: 9518
Repair Type: Urgent
Crossing Status: Found
UCIP Comments: 07/31/2019 Record has been updated from No Action Needed to Urgent due to the slide gate removed from the CMP riser located on the WS. There is currently no way to control flow from the WS to LS. Need to audit this record to accurately determine current owner, permits issued for pipe and pump station, schematics of water distribution through this area, and to obtain maintenance records for both 48-inch pipe and pump station. Coordinates were changed from 39.270492, -122.001306 to 39.270351, -121.999183 to reflect correct structure point. (O. Magana - DWR UCIP)04/19/2017 Pipe appears to be in good condition. There is some damage to the WS headwall but it should not affect the operation of the pipe or the levee integrity. (DWR Sutter Yard- Afreitag)10/31/2016 Crossing appears to be in good condition. (DWR Sutter Yard- Afreitag)06/01/2016 Crossing appears to be in good condition.04/01/2015 Pipe is in good condition but the WS concrete headwall is damaged but it is not affecting the levee or operation of the pipe. Two pumps 600 ft upstream of CMP crossing. Switch panel on separate shed.06/30/2014 Same as last inspection.12/18/2013 Same as last inspection.07/23/2013 Same as last inspection.

FIELD_STRUCT_DESC: 48-inch corrugated metal irrigation pipe through the levee, 17 feet below the crown. Slide gate in a 60-inch corrugated metal pipe (CMP) riser on the waterside (WS) slope. Water transfer ditch from the pump on the riverbank, located about 600 feet upstream (39.2705001, -122.0010317), to the pipe. Discharges into a concrete box on the landside (LS) toe. (48-inch pipe [HLM 10.27] and water transfer ditch from pump on river-bank to pipe authorized under Automatic Board Order (ABO) issued as Permit No. 9518, 1974 - Lewis). [Additional Reference(s): DWR Levee Log, 2002. USACE Sacramento O&M Manual 136, March 1960 (HLM 10.27)].
FS Date: 7/31/2019 1:54:00 PM

WS view: overview of pump station

WS view: water conveyor (PVC pipe and ditch)

WS view: overview of water conveyor and crossing

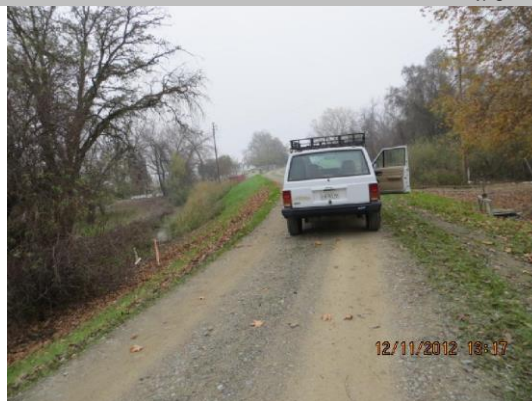
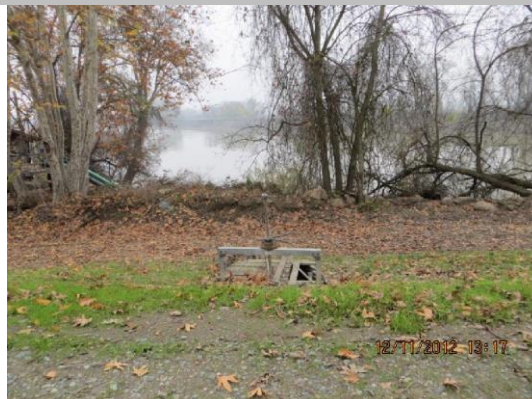
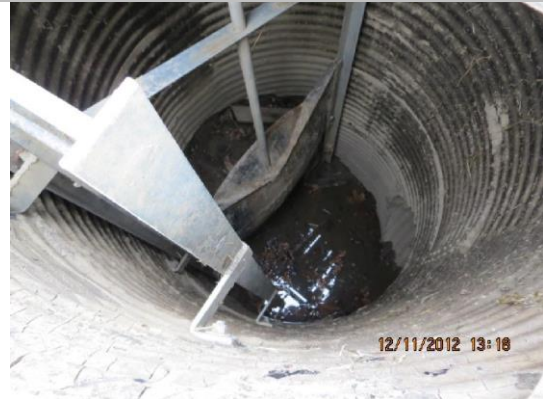
DS_ID:17358
FS_ID:55558
EP_NO: 9517
Repair Type: Non-Urgent
Crossing Status: Found
UCIP Comments: 07/31/2019 Record has been updated from No Action Needed to Non-Urgent; slide gate handle is still damage and CMP riser lid needs to be repaired. Recommend auditing this record to determine current owner for 48-inch pipe and to obtain maintenance records for ditch and pipes running along LS toe. (O. Magana - DWR UCIP)04/19/2017 No WS end found/ slide gate handle broken. (DWR Sutter Yard- Afreitag)10/31/2016 Slide gate handle is broken and no WS pipe end can be located. (DWR Sutter Yard- Afreitag)06/01/2016 WS slide gate handle is still broken. No WS pipe end was found.04/01/2015 Slide gate handle is still broken. The rest of the pipe appears in good condition. Broken slide gate handle found on WS.06/30/2014 Same as last inspection.12/18/2013 Same as last inspection.07/23/2013 Same as last inspection.

Crown view: overview (both sides of the levee)

WS view: overview of CMP riser

WS view: inside CMP riser

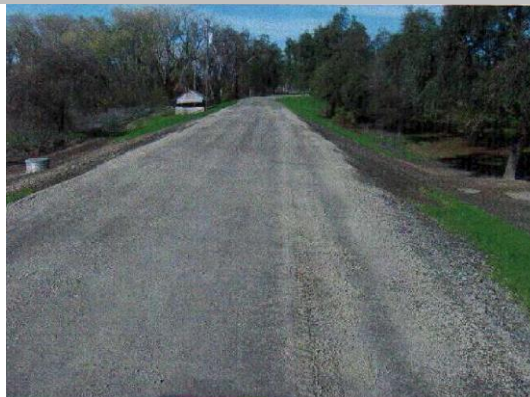
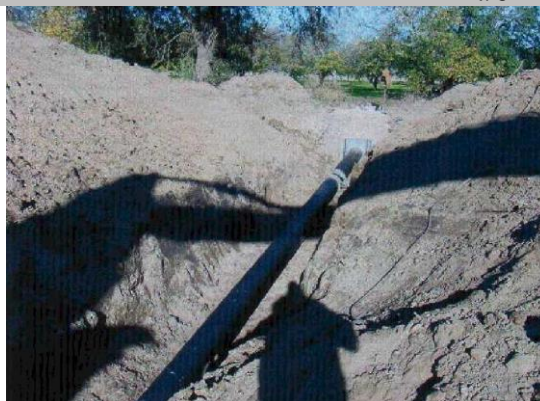
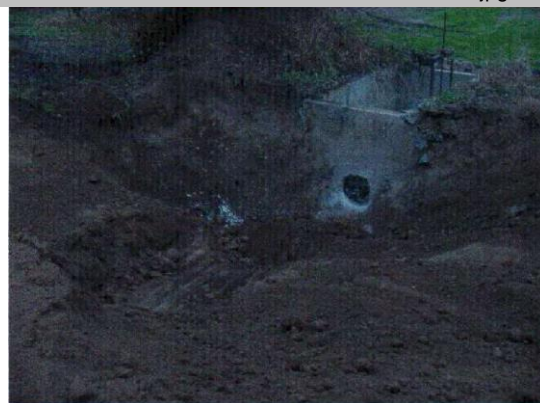
DS_ID:17507
FS_ID:55560
EP_NO: 17860
Repair Type: Non-Urgent
Crossing Status: Found
UCIP Comments: 11/08/2019 The record has been updated to Non-Urgent based on the 07-31-2019 inspection, pipe has been abandoned. Pump has been removed from the WS. Need to contact owner to determine status of pipe. If pipe is no longer in use, the owner will need to coordinate with the CVFPB to properly remove or abandon the pipe per Title 23 requirements. (O. Magana - DWR UCIP)09/17/2019 Spoke to T. Davis with Davis Machine Shop and this pipe is still present through the levee. This pipe was previously referenced under DSID 17371 which was incorrect, pipe associated with DSID 17371 was removed in 2004. Coordinates have been updated from 39.278517, -122.014589 to 39.271960, -122.003447 based on the confirmation from Mr. Davis with Davis Machine Shop that the 18-inch irrigation pipe was installed at this location. Inspection notes from 07-31-2019 and photos have been transferred from DSID 17371 to DSID 17507. During the inspection completed in July 2019, no issues were found on WS or LS. Pump and pipe daylight were not visible due to the dense vegetation along the berm slope. Assume pump and switch panel are still not connected. Need to contact owner to determine if crossing has been abandoned. (O. Magana - DWR UCIP)

Permit No. 17860 (Nov 2004): looking upstream after removal of levee section for replacement of 18-inch pipe

Permit No. 17860 (Nov 2004): new 18-inch steel pipeline

Permit No. 17860 (Nov. 2004): Concrete box where old 18-inch pipe was removed

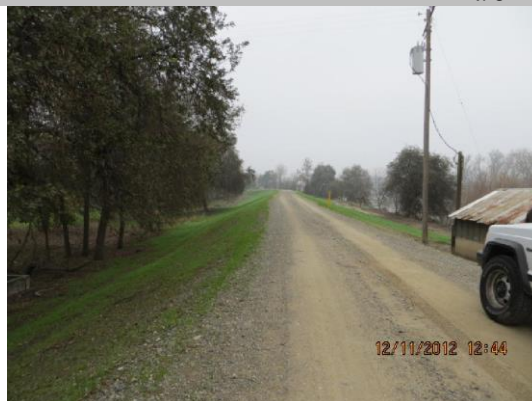
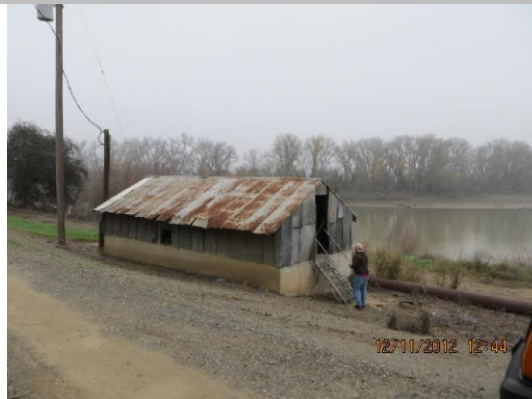
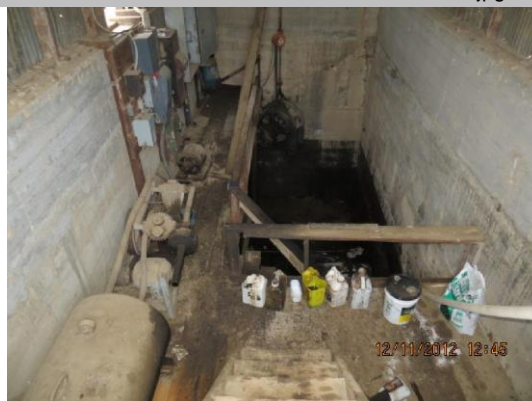
| DS_ID:17360 FS_ID:55561 EP_NO: 9517 Repair Type: Non-Urgent Crossing Status: Found UCIP Comments: 07/31/2019 Record has been updated from No Action Needed to Non-Urgent; signs of potential sink hole/slope failure found on WS berm edge which is over 15 feet from WS toe. Recommend LMA monitor this site to see progression of potential slope failure. Need to contact owner to obtain maintenance records for pumping station. Recommend having owner conduct an internal inspection to determine condition of pipe through the levee and WS berm. (O. Magana - DWR UCIP)04/19/2017 Crossing appears to be in good condition. (DWR Sutter Yard- Afreitag)10/31/2016 Crossing appears to be in good condition. (DWR Sutter Yard- AFreitag)06/01/2016 Crossing appears to be in good condition.04/02/2015 Same as last inspection. 06/30/2014 Same as last inspection.12/18/2013 Same as last inspection.07/23/2013 Same as last inspection.12/11/2012 A long steel pipe laying in WS berm. (P. Amatya - DWR UCIP) FIELD_STRUCT_DESC: 24-inch steel irrigation pipe through the levee, 20.1 feet below the crown. Pump house on the waterside (WS) berm. Concrete distribution box and flap gate on the landside (LS) toe. Water meter in a corrugated metal pipe (CMP) riser on the LS toe. (Automatic Board Order (ABO) issued as Permit No. 9517, 1974 - Griffin). [Additional Reference(s): DWR Levee Log, 2002. USACE Sacramento O&M Manual 136, March 1960 (HLM 10.57)]. FS Date: 7/31/2019 1:58:00 PM | | | | | | |

Crown view: overview (both sides of the levee)

WS view: overview- pump house

WS view: inside pump house, switch panel on wall

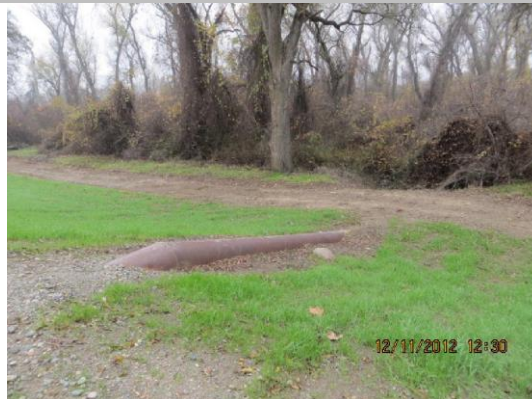
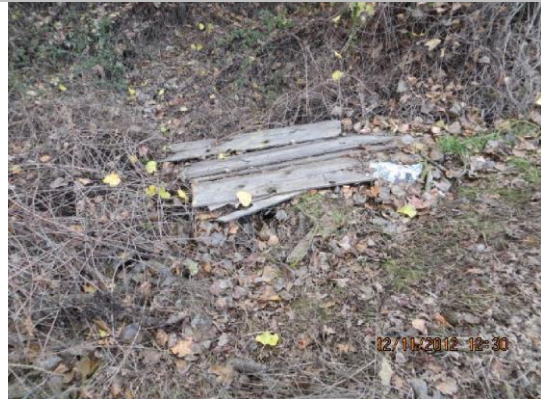
DS_ID:17350
FS_ID:56033
EP_NO: 1369
Repair Type: Non-Urgent
Crossing Status: Found
UCIP Comments: 07/31/2019 The record remains Non-Urgent; siphon breaker is damage and crossing appears to be abandoned. Need to contact owner to determine status of pipe. If pipe is no longer in use, the owner will need to coordinate with the CVFPB to properly remove or abandon the pipe per Title 23 requirements. (O. Magana - DWR UCIP)04/19/2017 Abandoned- needs to be done so properly. (DWR Sutter Yard- Afreitag)10/31/2016 Appears abandoned. (DWR Sutter Yard- Afreitag)06/01/2016 Appears to be an abandoned crossing.04/02/2015 Same as last inspection. Looks abandoned and if so should be done so properly. Pump and switch panel not found. Outlet pipe blocked by silt and debris.06/30/2014 Same as last inspection.12/18/2013 Same as last inspection.07/23/2013 Same as last inspection.
FIELD_STRUCT_DESC: *ABANDONED* 24-inch steel irrigation pipe through the levee, 4 feet below the crown. Siphon breaker on the landside (LS) slope. Concrete distribution box on the LS toe. (Permit No. 1369, 1949 - Griffin). [Additional Reference(s): DWR Levee Log, 2002. USACE Sacramento O&M Manual 136, March 1960 (HLM 10.68)].

Crown view: overview (both sides of the levee)

WS view: overview of exposed steel pipe

WS view: beyond exposed steel pipe (not accessible)

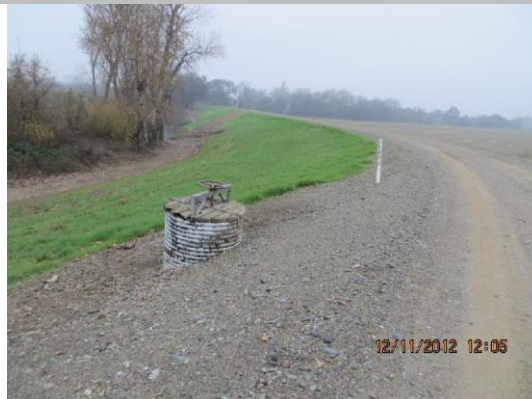
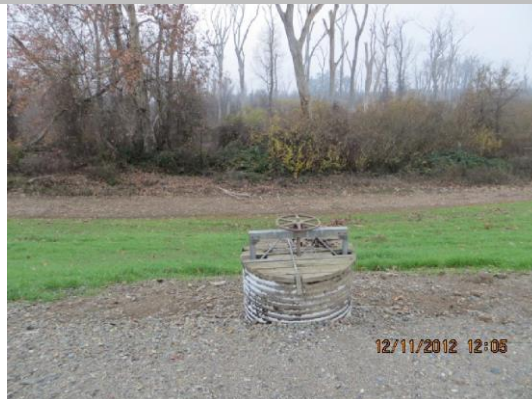
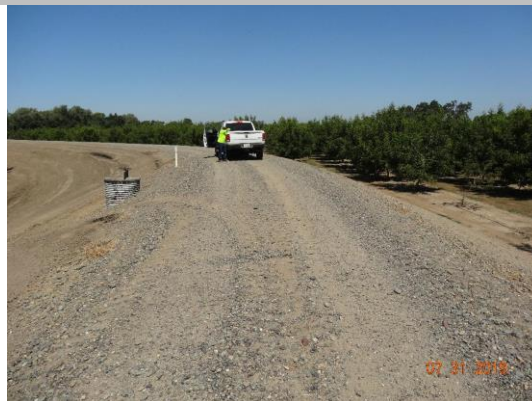
| DS_ID:17362 FS_ID:56034 EP_NO: 9515 Repair Type: Non-Urgent Crossing Status: Indicator Found UCIP Comments: 07/31/2019 Record has been updated from No Action Needed to Non-Urgent, pipe has been abandoned. DWR DMP geophysical investigation results confirmed evidence of pipe still likely exists through levee. No OMRR&R will be performed until funding becomes available. This section of the levee will need to be monitored for any integrity issues associated with abandoned pipe. Coordinates have been updated from 39.277837, -122.008081 to 39.277960, -122.008222 based on the geophysical study. Need to review record to clarify ownership. (O. Magana - DWR UCIP)04/19/2017 Abandoned-needs to be done properly. (DWR Sutter Yard- Afreitag)10/31/2016 Appears abandoned. (DWR Sutter Yard- AFreitag)06/01/2016 Appears to be an abandoned crossing.04/02/2015 Same as last inspection. Only CMP riser is found. Only CMP riser with slide gate found.06/30/2014 Same as last inspection.12/18/2013 Same as last inspection.07/23/2013 Same as last inspection. FIELD_STRUCT_DESC: *ABANDONED* 36-inch corrugated metal drainage pipe through the levee, 17.4 feet below the crown, not found in 2015. Slide gate in a 48-inch corrugated metal pipe (CMP) riser on the waterside (WS) slope, found in 2015. (36-inch pipe [HLM 10.99] authorized under Automatic Board Order (ABO) issued as Permit No. 9515, 1974 - O'Sullivan). [Additional Reference(s): DWR Levee Log, 2002. USACE Sacramento O&M Manual 136, March 1960 (HLM 10.99)]. FS Date: 7/31/2019 1:59:00 PM | | | | | |

WS view: overview of CMP riser

WS view: CMP riser with slide gate.

Overview of levee looking u/s towards pipe crossing.

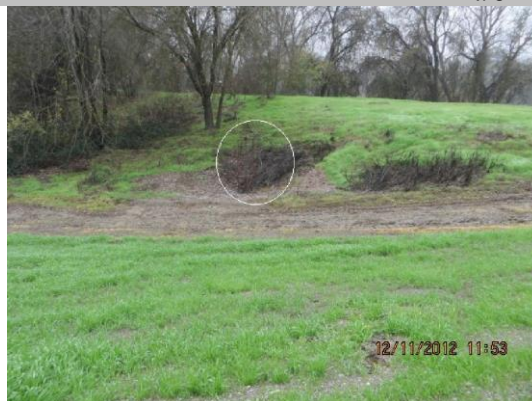
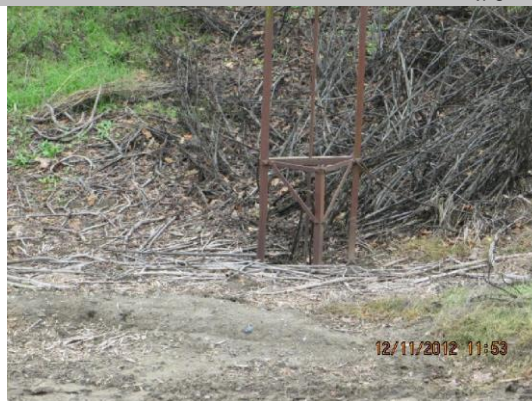
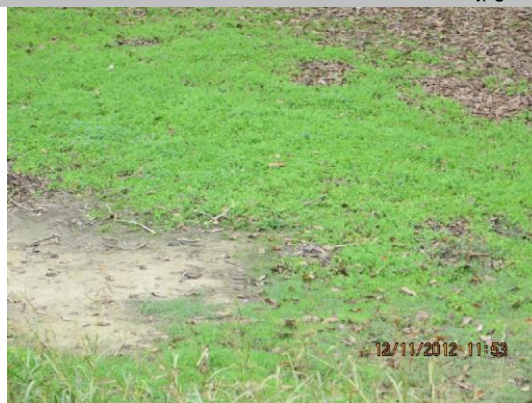
| DS_ID:17363 FS_ID:55566 EP_NO: 9516 Repair Type: Non-Urgent Crossing Status: Indicator Found UCIP Comments: 07/31/2019 Record has been updated from No Action Needed to Non-Urgent, pipe has been abandoned. DWR DMP geophysical investigation results confirmed evidence of pipe still likely exists through levee. No OMRR&R will be performed until funding becomes available. This section of the levee will need to be monitored for any integrity issues associated with abandoned pipe. Coordinates have been updated from 39.279691, -122.016862 to 39.279715, -122.016889 based on the geophysical study. Need to review record to clarify ownership. (O. Magana - DWR UCIP)04/19/2017 Abandoned-needs to be done properly. (DWR Sutter Yard- Afreitag)10/31/2016 Appears abandoned. (DWR Sutter Yard- AFreitag)06/01/2016 Appears to be an abandoned crossing.04/02/2015 Same as last inspection. Only slide gate steel structure found.06/30/2014 Same as last inspection.12/18/2013 Same as last inspection.07/23/2013 Same as last inspection. FIELD_STRUCT_DESC: *ABANDONED* 24-inch corrugated metal drainage pipe through the levee, 16.8 feet below the crown, not found in 2015. Slide gate at the waterside (WS) end, found in 2015. (24-inch pipe [HLM 11.5] authorized under Automatic Board Order (ABO) issued as Permit No. 9516, 1974 - Cone). [Additional Reference(s): DWR Levee Log, 2002. USACE Sacramento O&M Manual 136, March 1960 (HLM 11.5)]. FS Date: 7/31/2019 2:00:00 PM | | | | | | |

WS view: overview of slide gate on steel structure

WS view: slide gate (buried) on steel structure

LS view: overview (no pipes)

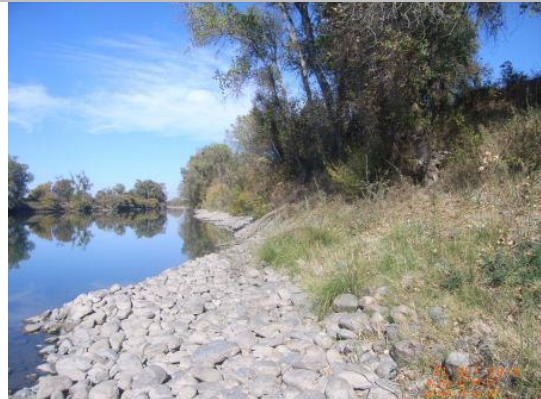
USACE 2013 Photo #1

| Site History: 2008 - Large rotational/mass failure in the bank with tree slump. 2009 - Minimal new erosion, the tree is leaning further into the river. 2011 - Site extended downstream. 2012 - Minor new erosion and tree roots are further exposed. | | | | | |

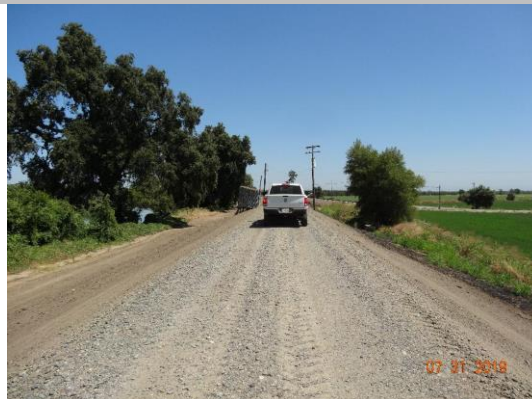
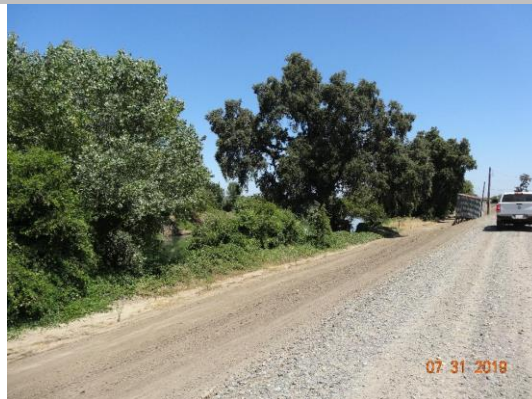
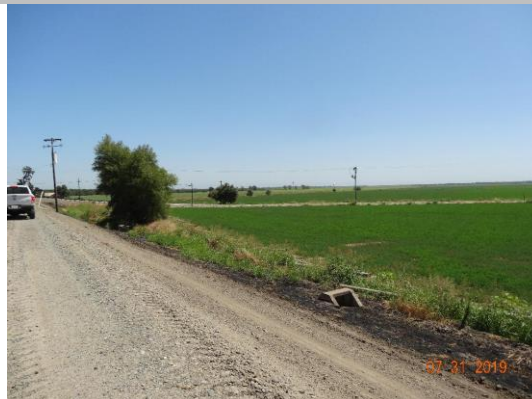
DS_ID:17491
FS_ID:55567
EP_NO: N/A
Repair Type: Non-Urgent
Crossing Status: Not Found
UCIP Comments: 07/31/2019 Record has been updated to Non-Urgent, pipe has been abandoned. DWR DMP geophysical investigation results confirmed evidence of pipe still likely exists through levee. No OMRR&R will be performed until funding becomes available. This section of the levee will need to be monitored for any integrity issues associated with the abandoned pipe. Coordinates have been updated from 39.283898, -122.015642 to 39.284063, -122.015534 based on the geophysical study. This pipe is not related to permit number 17860 (dsid 17507). (O. Magana - DWR UCIP)04/19/2017 Unable to locate. (DWR Sutter Yard- Afreitag)10/31/2016 Unable to locate.(DWR Sutter Yard- Afreitag)06/01/2016 Unable to locate.06/30/2014 Same as last inspection.04/02/2014 Unable to locate.12/18/2013 Unable to locate.07/23/2013 Same as last inspection. Unable to locate.

Overview of levee crown looking u/s towards pipe crossing.

WS view: overview of WS.

LS view: overview of LS.

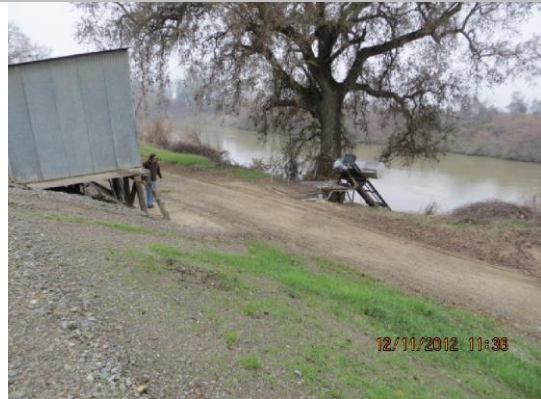
| DS_ID:17364 FS_ID:55568 EP_NO: 9495 Repair Type: Non-Urgent Crossing Status: Found UCIP Comments: 07/31/2019 Record has been updated from No Action Needed to Non-Urgent, no permit has been found authorizing the modifications for this structure. Recommend having record audited to make sure the ABO issued as permit number 9495 includes the modifications at this location. At the pipe daylight near the concrete box located on the WS berm, the soil has been disturbed with potential pipe leak. (O. Magana - DWR UCIP)04/19/2017 Crossing appears to be in good condition. (DWR Sutter Yard- Afreitag)10/31/2016 Crossing appears to be in good condition.(DWR Sutter Yard- Afreitag)06/01/2016 Crossing appears to be in good condition.04/02/2015 20 inch steel pipe sleeved through 40-inch steel pipe (visible on LS). Same as last inspection.07/02/2014 Same as last inspection.12/18/2013 Same as last inspection.07/23/2013 Same as last inspection. FIELD_STRUCT_DESC: 40-inch steel irrigation pipe, with a 20-inch steel pipe sleeved through it, through the levee, 15.7 feet below the crown (not 36-inch, as stated in the O&M Manual, Automatic Board Order, or Levee Log). Slant pump on the waterside (WS) bank. Vent on the apex of the pipe on the WS bank. Electrical switch board house and service pole on the WS. Slide gate in a concrete surge box on the WS bank. Pipe discharges into a concrete distribution box on the landside (LS) toe. (Automatic Board Order (ABO) issued as Permit No. 9495, 1974 - Wells). [Additional Reference(s): DWR Levee Log, 2002. USACE Sacramento O&M Manual 136, March 1960 (HLM 11.84)]. FS Date: 7/31/2019 2:02:00 PM | | | | | |

WS view: overview of switch panel shed and pump

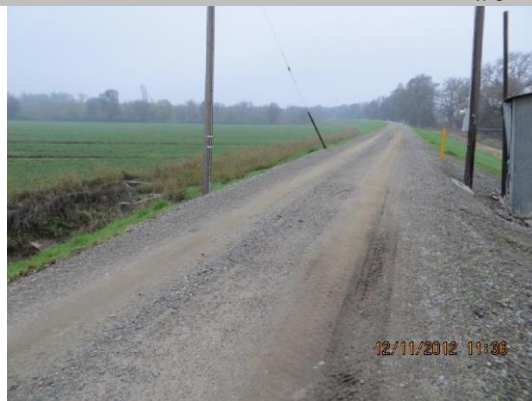
Photo 2 of 3 : UCIP_SP_2020_55568_47295.jpg

Crown view: overview (both sides of the levee)

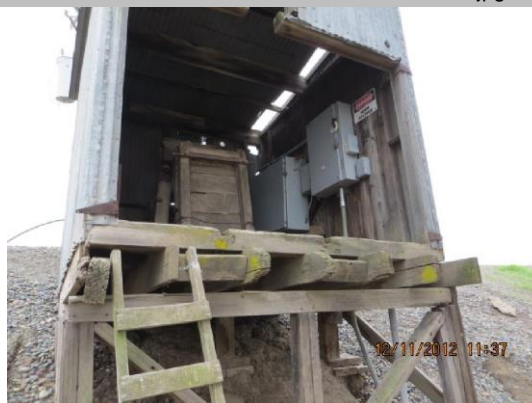
Photo 3 of 3 : UCIP_SP_2020_55568_47300.jpg

Crown view: switch panel in CM sheet shed

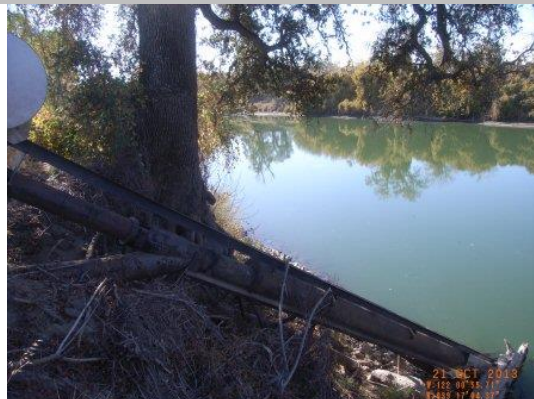
Photo 1 of 1 : SP_2020_ST0003_264_13_20200226_00007.jpg

| 2017 Field Notes: Minor new erosion observed. | | | | | |
| Site History: 2006 - Large rotational/mass failure in the bank with tree slump. Tough clayey toe material. 2007 - Site is between stone revetments with a pump station at the downstream end. 2010 - Erosion is into the levee toe. 2011 - Minor new erosion. 2012 - Minor new erosion. | | | | | |

USACE 2013 Photo #1

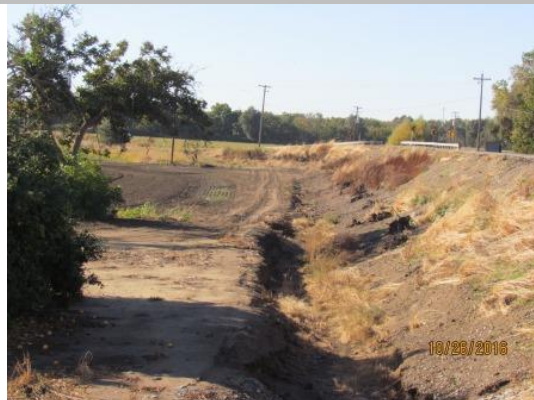
Photo 1 of 1 : SP_2020_ST0003_264_7_20200226_00004.jpg

View of the ditch along the landside toe.

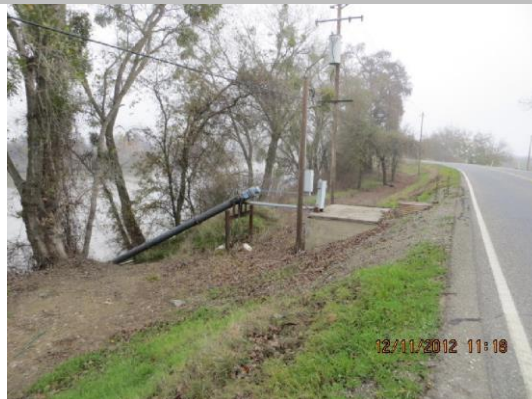
Photo 1 of 3 : UCIP_SP_2020_55569_47306.jpg

DS_ID:17365
FS_ID:55569
EP_NO: 9514
Repair Type: Non-Urgent
Crossing Status: Found
UCIP Comments: 08/01/2019 Record remains Non-Urgent due to safety issue and ABO issued for this structure. Need to audit this record to confirm ABO issued as permit number 9514 is still valid for current structure. The levee also serves as county road, River Road. Recommend an internal inspection of this crossing as a safety precaution based on the age of this structure and dual purpose use of the levee/county road (River Road). (O. Magana - DWR UCIP)04/19/2017 Crossing appears to be in good condition. (DWR Sutter Yard- Afreitag)10/31/2016 Crossing appears to be in good condition.(DWR Sutter Yard- Afreitag)06/06/2016 Crossing appears to be in good condition. New wooden cover was made for WS surge tank.04/02/2015 Everything looked to be in good condition. Concrete surge tank still has some silting. Gate valve in CMP riser not visible. Flap gate in concrete distribution box on LS not visible/accessible. Looks like cleaning required inside concrete surge tank on WS due to silting.07/02/2014 Same as last inspection.12/30/2013 Same as last inspection.07/29/2013 Pump running and WS surge tank was full of water so not sure if silt was cleaned out. LS flap gate was visible and is in good condition.

FIELD_STRUCT_DESC: 36-inch corrugated metal irrigation pipe through the levee, 18.1 feet below the crown. Pump house on the waterside (WS) slope. Gate valve in a corrugated metal riser on the WS toe. Flap gate in a concrete distribution box at the landside (LS) toe. (Automatic Board Order (ABO) issued as Permit No. 9514, 1974 - Boggs). [Additional Reference(s): Levee Log, 2002. USACE Sacramento O&M Manual 136, March 1960 (HLM 12.05)].
FS Date: 8/1/2019 8:25:00 AM

WS view: overview pipe, pump, surge box & CMP riser

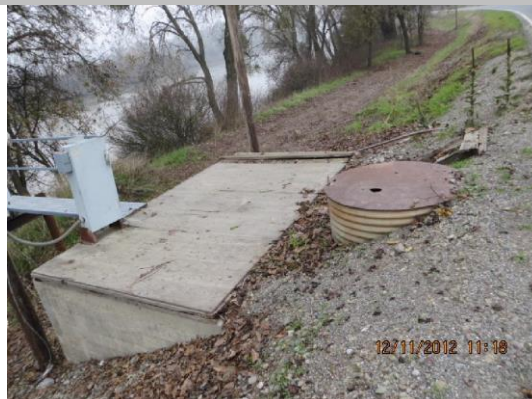
Photo 3 of 3 : UCIP_SP_2020_55569_47304.jpg

WS view: pump switch box, surge box & CMP riser

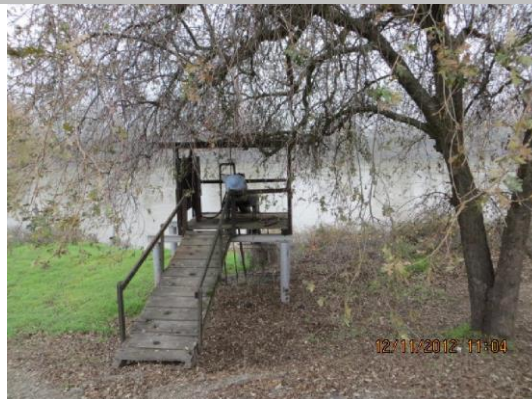
Photo 1 of 3 : UCIP_SP_2020_55570_47313.jpg

DS_ID:17366
FS_ID:55570
EP_NO: 9513
Repair Type: Non-Urgent
Crossing Status: Found
UCIP Comments: 08/01/2019 Record remains Non-Urgent, need to audit record to confirm owner. Pipe was running during site inspection. Recommend auditing this record to confirm ABO issued as permit number 9513 is still valid for current structure. The levee also serves as a county road, River Road. Recommend an internal inspection of this crossing as a safety precaution based on the age of this structure and dual purpose use of the levee/county road (River Road). Previously rigid 2.5 inch pipe has been replaced with a flexible hose that can be easily removed to allow the slide gate to fully close during flood season, as noted in the 2017 inspection. (O. Magana - DWR UCIP)04/20/2017 2.5in. GI pipe was removed and replaced with a section of 2.5in. flexible hose that can easily be removed to allow the slide gate to fully close for high water season. (DWR Sutter Yard-Afreitag)10/31/2016 2.5in. pipe still blocking the screw gate. (DWR Sutter Yard- Afreitag)06/06/2016 2.5inch pipe still present through crossing. (DWR Sutter Yard - afreitag)04/14/2016 2.5-inch pipe still preventing slide gate from fully closing on WS. Recommend LMA contact owner to address removal of unauthorized 2.5-inch pipe. Owner must either contact CVFPB for permitting of 2.5-inch pipe or remove it. (DWR UCIP - kfazel)04/02/2015 2.5in pipe is still present and prevents the slide gate from fully closing. (DWR Sutter Yard - afreitag)07/02/2014 2.5in. GI pipe and chain in WS surge box will prevent slide gate from closing fully for high water season. (DWR Sutter Yard - afreitag)12/30/2013 Same as last inspection. (DWR Sutter Yard - afreitag)07/29/2013 2.5in. GI pipe and chain in WS surge box will prevent slide gate from closing fully for high water season. (DWR Sutter Yard - afreitag)12/11/2012 A 2.5 inch GI pipe through 36 inch CMP found. A 2 inch electrical conduit also found. (DWR UCIP - pamatya)

FIELD_STRUCT_DESC: 24-inch corrugated metal irrigation pipe through the levee, invert 16.5 feet below the crown. Slide gate in a concrete surge box on the waterside (WS) berm. 2.5-inch pipe through the 24-inch pipe preventing closing of the slide gate on the WS. Slant pump on the riverbank. Concrete distribution box at the landside (LS) toe. 2-inch electrical conduit through the levee, visible on the WS adjacent to the walkway. (Automatic Board Order (ABO) issued as Permit No. 9513, 1974 - Boggs). [Additional Reference(s): DWR Levee Log, 2002. USACE Sacramento O&M Manual 136, March 1960 (HLM 12.42)].
FS Date: 8/1/2019 8:27:00 AM

WS view: overview of slanted pump and shed

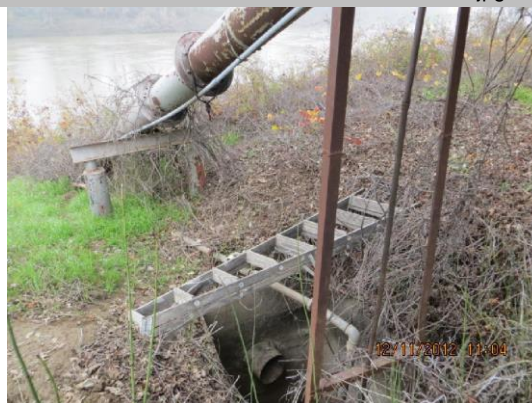
Photo 3 of 3 : UCIP_SP_2020_55570_47311.jpg

WS view: steel pipe, GI pipe in concrete surge box

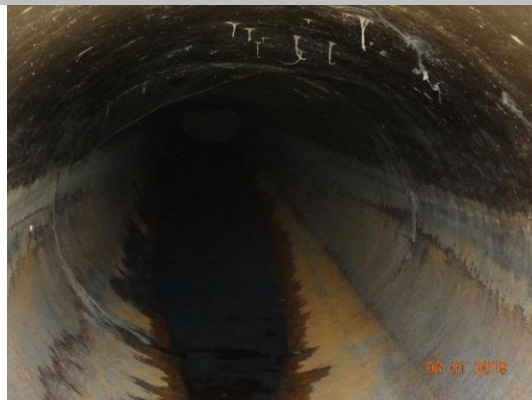
Photo 2 of 3 : UCIP_SP_2020_55571_81991.jpg

LS view: inside view of 48-inch pipe.

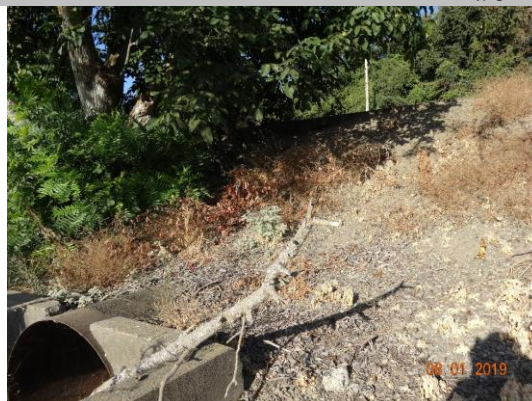
Photo 3 of 3 : UCIP_SP_2020_55571_81992.jpg

LS view: overview of LS slope.

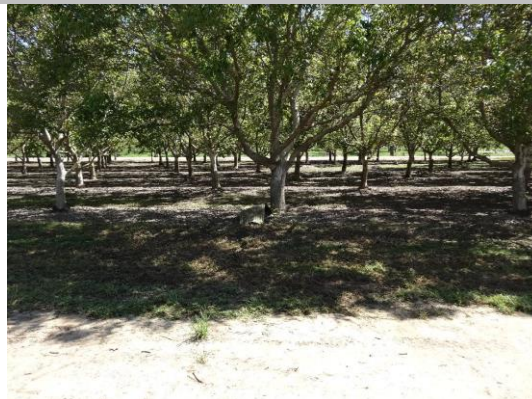
Photo 1 of 3 : UCIP_SP_2020_55574_75075.jpg

DS_ID:17368
FS_ID:55574
EP_NO: N/A
Repair Type: Non-Urgent
Crossing Status: Indicator Found
UCIP Comments: 08/01/2019 Pipe remains Non-Urgent; internal inspection found some issues (see internal inspection report and notes recorded on 06-14-16), pipe appears to be abandoned and no permit has been found for this pipe. Need to clarify who owns this crossing. (O. Magana - DWR UCIP)04/20/2017 Abandoned- needs to be done properly. (DWR Sutter Yard- A Freitag)10/31/2016 Appears abandoned. (DWR Sutter Yard- A Freitag)06/14/2016 Pipe was internally cleaned and camera inspected on 11/5/2015 by Nor-Cal Pipeline Services. Pipe length is 86.7ft long. The is a possible sag in the pipe between the WS riser and LS end as we could not get all the water to drain or be sucked out after the cleaning was done. Internal inspection showed signs of some rusting but no visible holes or other deterioration were found. After the inspection pipe ends were capped and reburied. 04/14/2016 Same as last inspection. Heavy vegetation along WS slope, especially below WS berm, limits visibility.04/02/2015 WS and LS pipe ends have been dug up in preparation for internal camera inspections. 07/02/2014 Same as last inspection.12/19/2013 Same as last inspection.07/23/2013 Same as last inspection.12/11/2012 Only CMP riser found. (P. Amaty - DWR UCIP)

FIELD_STRUCT_DESC: *ABANDONED* 12-inch drainage pipe of an unknown material through the levee, 14 feet below the crown, not found in 2016. Slide gate in a corrugated metal pipe 36-inch riser (CMP) on the waterside (WS) slope, found in 2016. [Additional Reference(s): DWR Levee Log, 2002. USACE Sacramento O&M Manual 136, March 1960 (HLM 12.73)].
FS Date: 8/1/2019 1:49:00 PM

View of landside from crown.

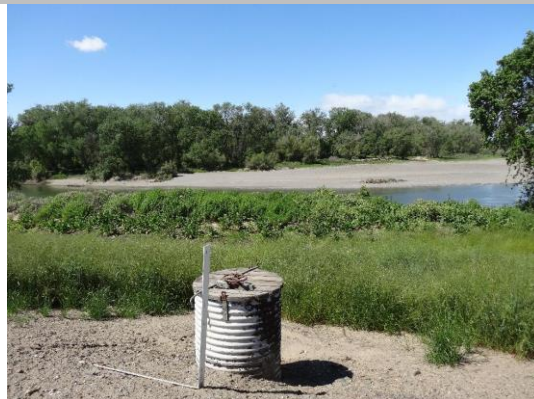
Photo 2 of 3 : UCIP_SP_2020_55574_75076.jpg

WS view: 12-inch slide gate inside CMP riser on WS slope.

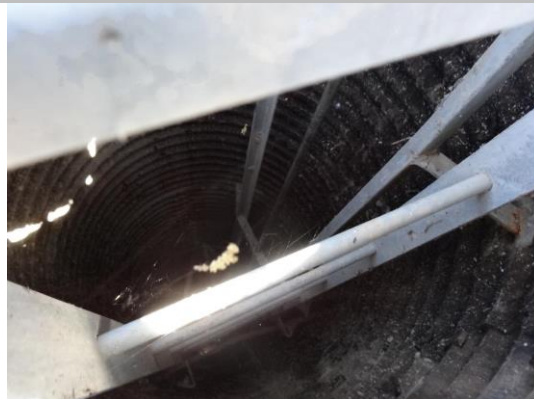
Photo 3 of 3 : UCIP_SP_2020_55574_75077.jpg

WS: slide gate inside CMP riser.
